Mobile Infrared Scanning – A High-Tech, Accurate Alternative To Traditional Bridge Inspection Methods

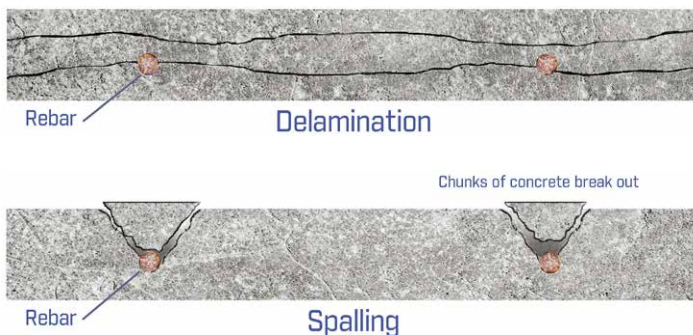
Two major factors in concrete bridge damage are delamination and spalling. Delamination is the separating of concrete into layers, or the separating of the top coating from the substrate. Embedded reinforcing bar (rebar) corrodes over time, causing expansion that splits the concrete either horizontally through

the layers (delamination) or into chunks that break off above the damaged area (spalling).

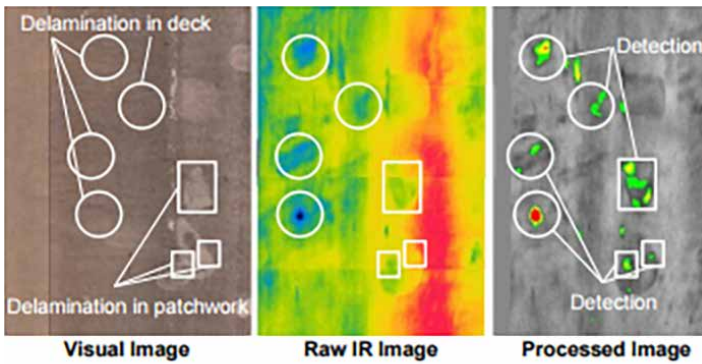
Visual, raw, and processed delamination images from IR survey of bridge deck

A high-tech alternative to acoustic chain drag inspections uses a truck-mounted infrared camera to pinpoint delaminated areas on concrete deck surfaces. NEXCO-West USA developed this NDT inspection technique, which incorporates images from a cooled FLIR infrared camera into maps created with NEXCO-West's proprietary software. Company engineers are now working with the University of Central Florida to develop objective and efficient bridge inspection procedures that could be used by state highway agencies across the US.

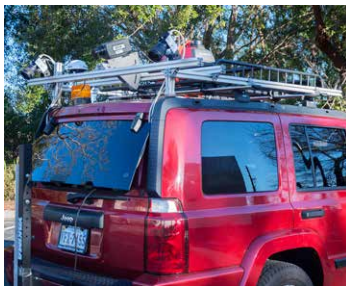
NEXCO-West's mobile survey setup

"NEXCO-West's approach to testing for bridge delamination is a mobile method, using an infrared camera installed on top of the vehicle," says company President and CEO, Masato Matsumoto. "Our approach does not require lane closures or speed limit reductions, so it keeps traffic flowing while simultaneously keeping inspectors safe."

Inspections are performed with a truck-mounted infrared camera while driving across the bridge at 50 miles per hour with traffic. Matsumoto says it only takes a few minutes for the infrared camera to record an entire scan of one lane of a one-mile long bridge.

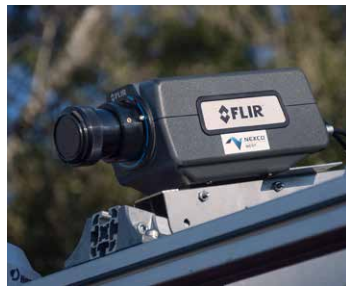
FLIR A6701sc camera used to create infrared delamination maps

The camera employed in NEXCO-West's scanning system is a FLIR A6701sc MWIR science camera. "We use the A6700 series camera because it can photograph high resolution thermal images while driving at high speed," explains Matsumoto. This camera's cooled Indium Antimonide detector offers integration times as fast as 0.48 μs, allowing the team to record 640 x 512 pixel thermal images without any motion blur. Matsumoto says they typically set the camera for a 10 Hz frame rate, which allows it to record a crisp thermal image every two meters at highway speed. The camera is connected to a laptop inside the vehicle that is running NEXCO-West's Infrared Bridge Assessment System (IrBAS) software, so the team can see real-time analysis and recognize potentially delaminated areas.

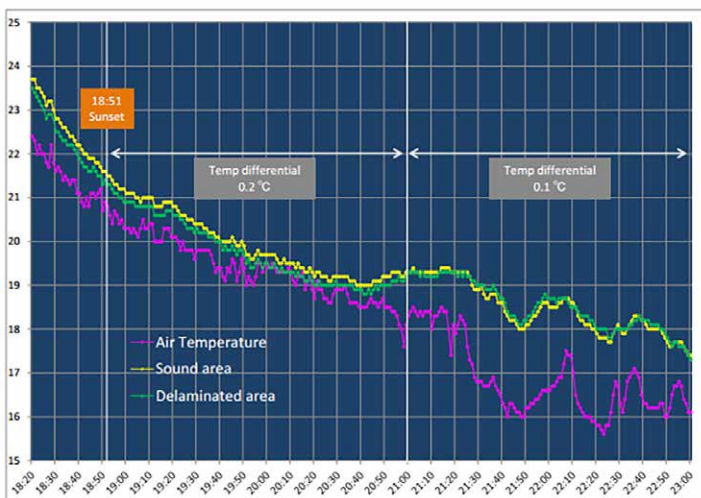
Example of temperature differential for sound and damaged concrete

Scans are usually performed during the day or within a few hours after sunset, when large temperature shifts can be observed. For example, concrete that heated up during the afternoon will begin to cool down after sunset, creating a measurable change in temperature. Most of the deck will heat or cool evenly, but delamination interrupts the conduction path. The temperature of the damaged concrete will rise more rapidly during the day and fall faster at night, which is easily detected by the IR camera.

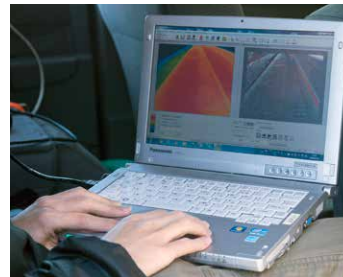
Laptop shows live-streaming infrared through NEXCO-West's IrBAS software

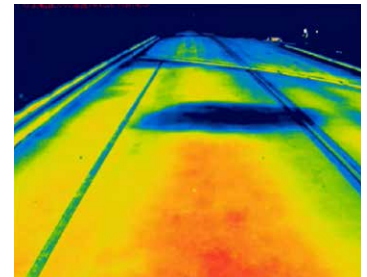
Thermal image used to create bridge deck deficiency map

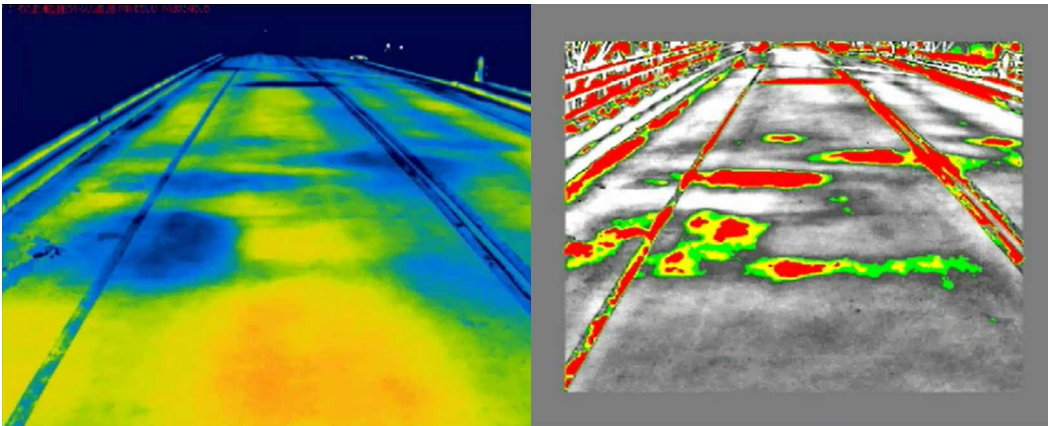
Thermal bridge scan (left) and IrBAS processed image used to create deck deficiency map (right)

After the team has collected data on each lane of the bridge, they can begin processing it. "Most of the data analysis and reporting processes are automated by the IrBAS software, which saves significant time and cost preparing deficiency maps," says Matsumoto. The software uses the deficiency map to calculate the percentage of delaminated deck area and then classify the condition states based on American Association of State Highway and Transportation Officials (AASHTO) criteria.
