FLIR GF320 THERMAL CAMERA OFFERS RELIABLE GAS LEAK DETECTION IN BIOGAS FACILITIES

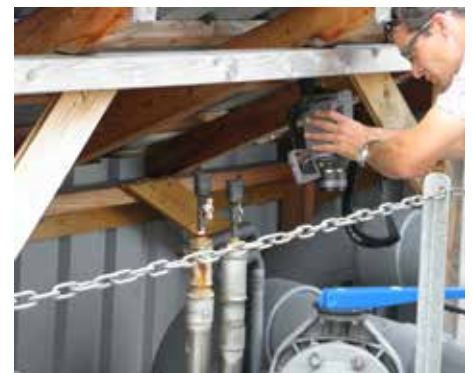
Engineer Ibeling van Lessen looking for gas leaks, which is possible from a safe distance and unusual angles using the FLIR GF320.

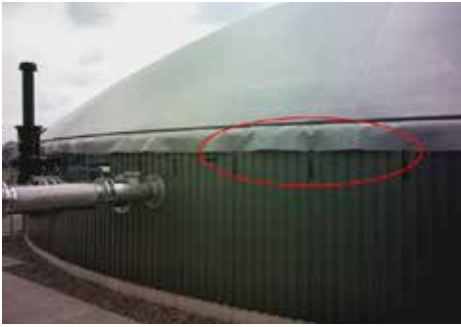
Gas leak on the terminal strip of the air-supported roof of a fermenter in the visible light spectrum - and in an infrared image made by the FLIR GF320.

methods are time-consuming, especially in hard-to-reach places. For example, a fermenter roof contains an inner gas membrane, eyelets for submersible mixers, and holes in the tank walls—all of which are difficult to access.

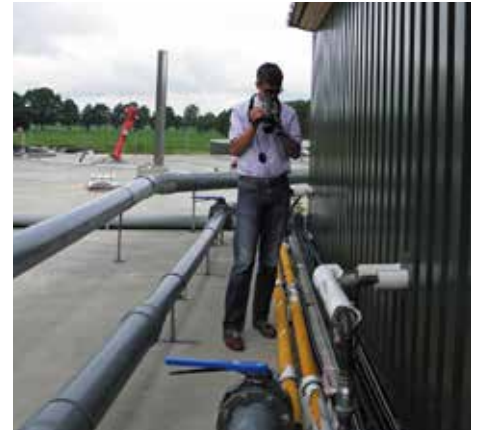
Explosion protected areas can be investigated from a safe distance with the FLIR GF320.

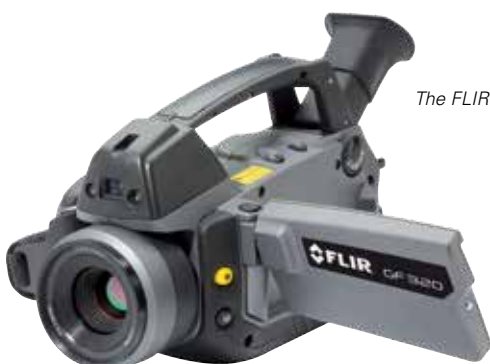
The FLIR GF320 thermal imager.
